PHASE I ENVIRONMENTAL SITE ASSESSMENT

Trans-Lite, Inc.

120 Wampus Lane Milford, Connecticut 06460

AMEC PROJECT 3610110095

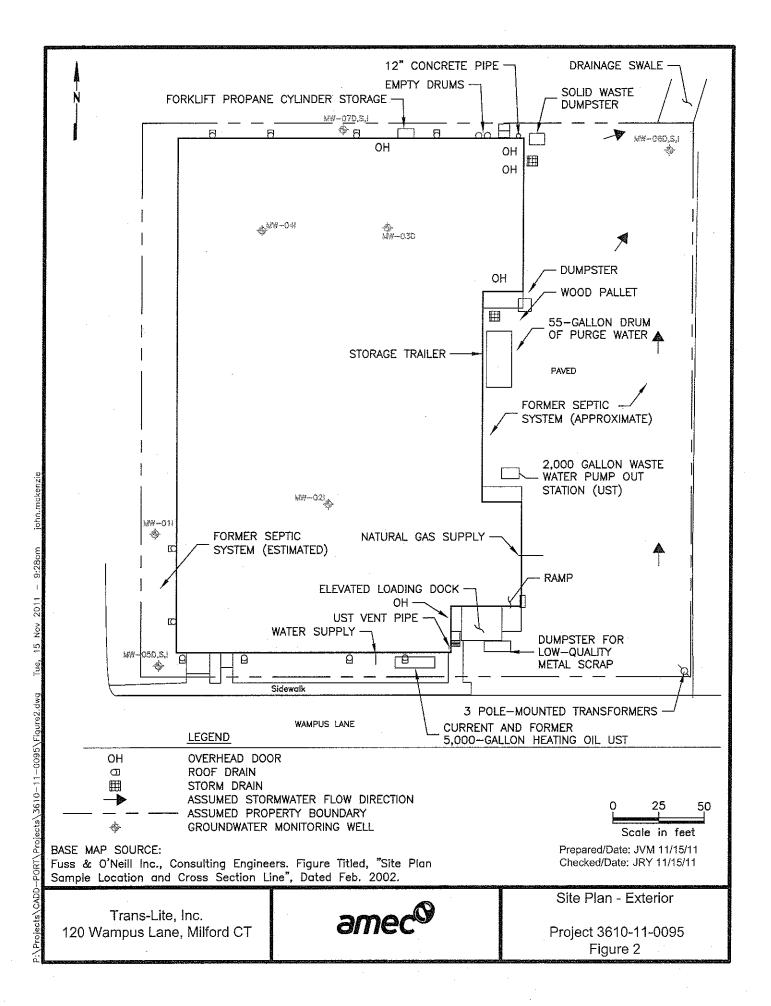
Figure 2 – Site Plan – Exterior

of the building as shown on Figure 2. This storage tank was installed in 1989 as a replacement for the original heating oil tank believed to have been installed when the initial building was constructed in the late 1950s. According to information reviewed, the tank was installed in August 1989, at which time the old tank was removed. A letter dated August 30, 1989 from Trans-Lite to CT DEEP indicated the tank removal process was in accordance with CT DEEP specifications and with Milford Fire Marshall inspection and approval. A letter dated August 24, 1989 from Charles B. Waterman Company to the CT DEEP provided results (4.7 mg/kg) for a composite of five soil samples collected from the "tank grave." Although the letter did not indicate the analytical parameter, it is likely the analysis was for TPH. Based on the available information, it does not appear that a release occurred from the historic tank. Copies of available documents are included in Appendix B.

According to Mr. Maley a sewer pump tank was installed on the eastern side of the Site beneath the parking area in 2002 to replace the original septic system tank when the facility applied to the city to discharge wastewater to the POTW. Prior to that time, wastewater discharged to the septic system. Copies of the excavator's proposal for abandonment of the historic septic system and installation of a 2,000-gallon pump station UST and the Board of Sewer Commissioners approval for the sewer connection are included in Appendix B. Records from the Milford Engineering Department confirm the capacity of the sewer pump tank (Appendix A).

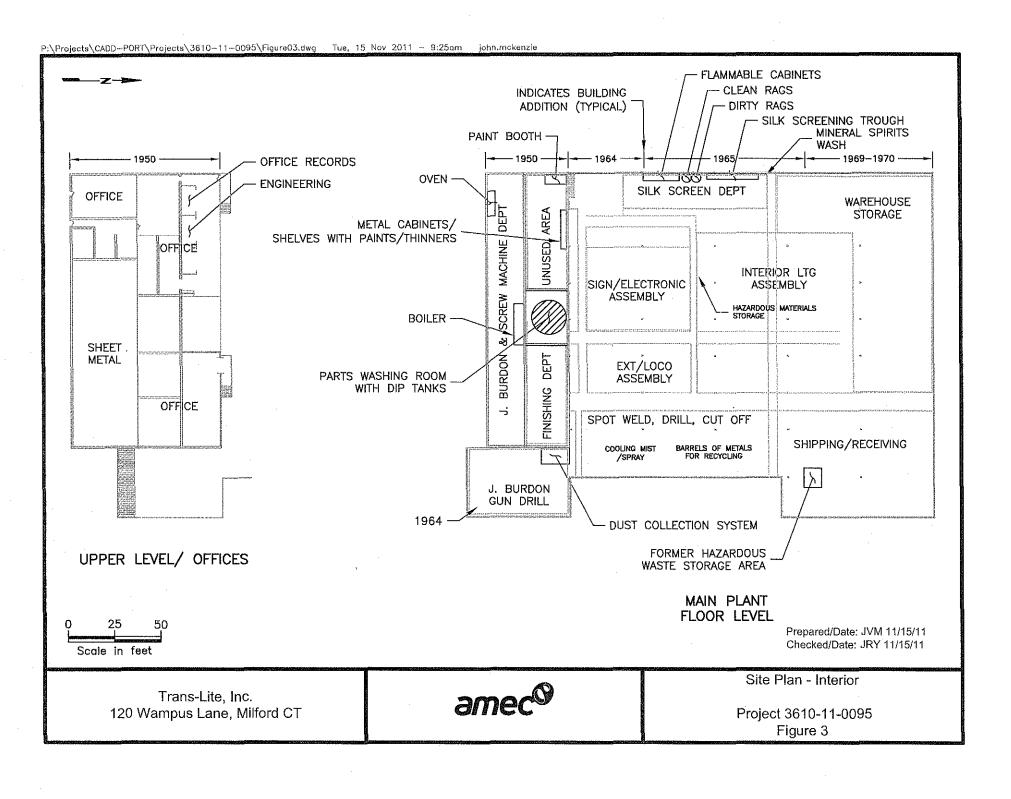
Figure 3 – Site Plan – Interior

Trans-Lite manufactures lighting for many types of subway and rail cars. The facility purchases aluminum and steel sheet metal and stock and therefore does not conduct foundry or casting operations at the Site. A large portion of the Trans-Lite operations include assembly of the lights with fabricated metal pieces and plastic or glass lenses. Metal from the suppliers is cut, machined, polished, and welded in the sheet metal fabrication area (Figure 3).
